Pipe installation on a mountain

Codelco Andina, TADA 1-2 Project

Chile | 2013-2014

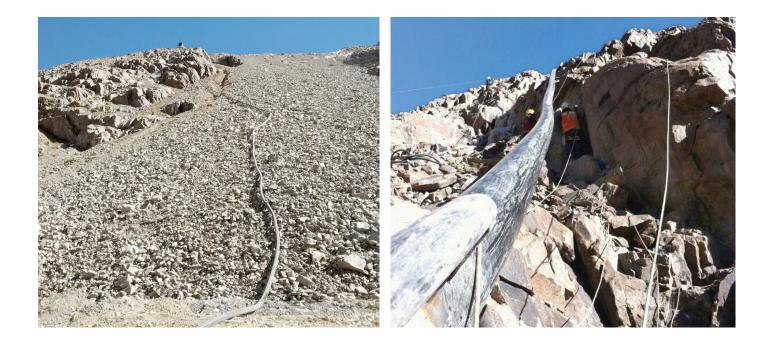
The installation was simplified by the use of Pexgol long sections. The pipes were unrolled from it coils and jointed trough electro-fusion, to be dragged and mapped out according to the project. The installation was done in perfect timing with an optimal
