Abrasive tailings transport Case Study | N°83

Installation of Pexgol pipe for the transport of abrasive tailings.

Pirquitas Mine Argentina | 2015

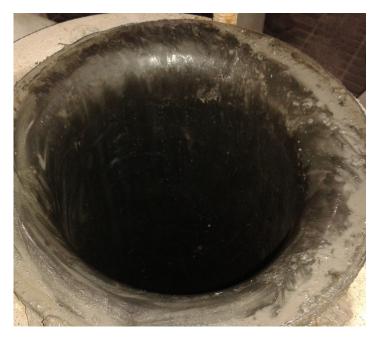
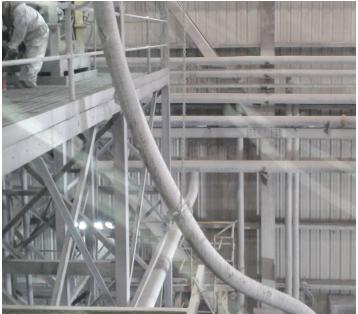
Installation of Pexgol pipe for the transport of abrasive tailings.
